# **Technical, Cost Effectiveness and Sustainability Audit, March 2016**

Poverty Reduction Fund Project (PRF)

## **Final Report**

## **Findings and Recommendations**

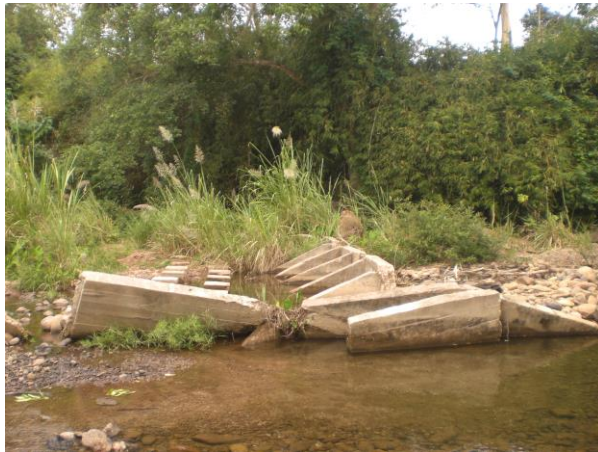
A curious case is an irrigation SP in Pachoucheun village, Saravan. The irrigation weir has failed almost totally and in a somewhat spectacular fashion. This concrete weir replaced a traditional wood/earth dam that had been positioned at this location in the past, part of a Lao *Meuang Fai* traditional irrigation system. The concrete weir was constructed in Cycle 8, 2010, and failed within a few years.

The villagers have grown to depend upon irrigation infrastructure at this location. It has historically allowed them to raise the local stream's elevation to send water to their fields at critical times of the rice season. Villagers have returned to their old practices, blocking portions of the broken weir to raise water levels as needed during the rice season. The Low Functionality of this SP has not prevented the villagers from continuing their ancient irrigation practices.

The PRF should be studying this failure carefully to learn about the dynamics of strongly flowing streams and water's power to destroy poorly designed concrete structures. Monies should be found to build a properly designed weir here.

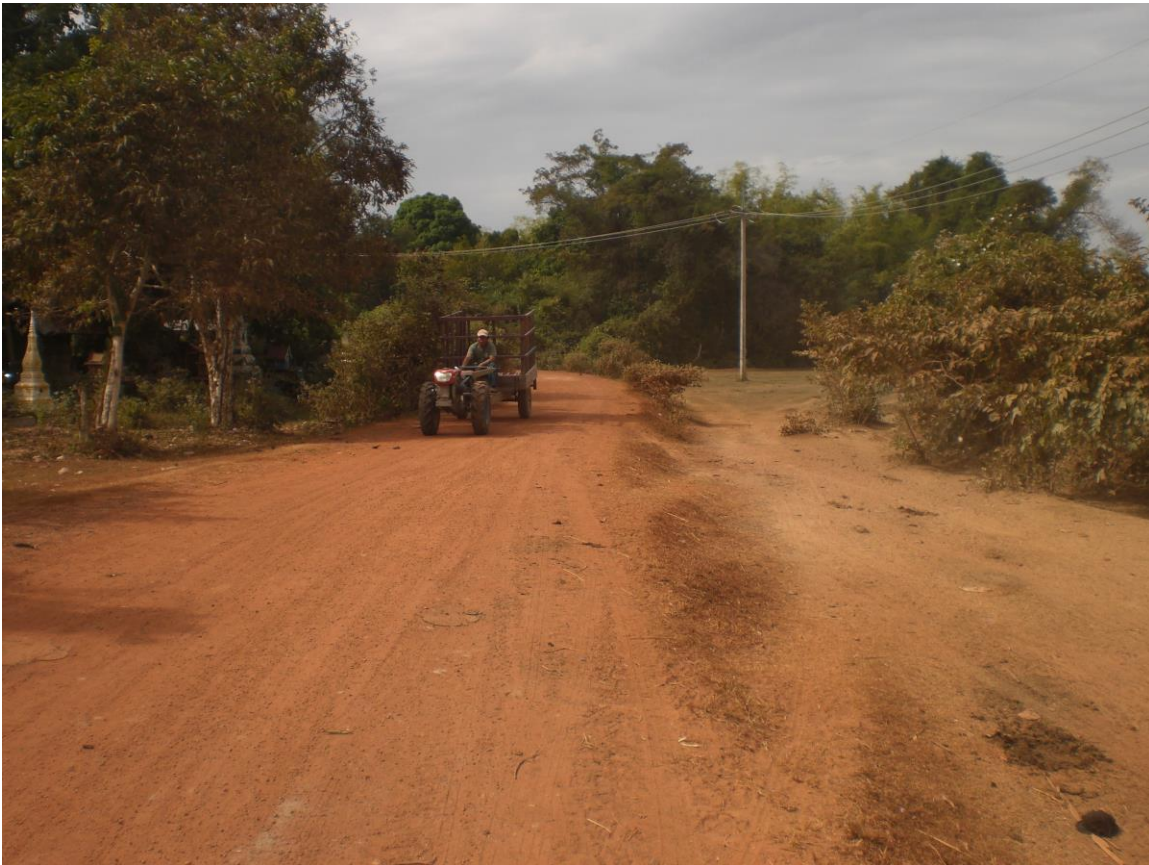
KDP Road Sub-Project in Thadeua, Kumban Sikhod, Thakhet District, Khammouane

Photographs were taken of all SP evaluated. It is apparent from viewing these photos that KDP has achieved a higher quality of final product. The KDP road photographs, such as that below, display well-graded gravels placed on a properly shaped road base. Examining this picture, one can discern the substantial amount of

road base and surface materials that have been imported to create this raised alignment. The elevation to which this road has been constructed promotes quick and effective drainage to both sides and away from the travelled surface. Stormwater runoff rapidly drains from the road with no pools left to become mud.

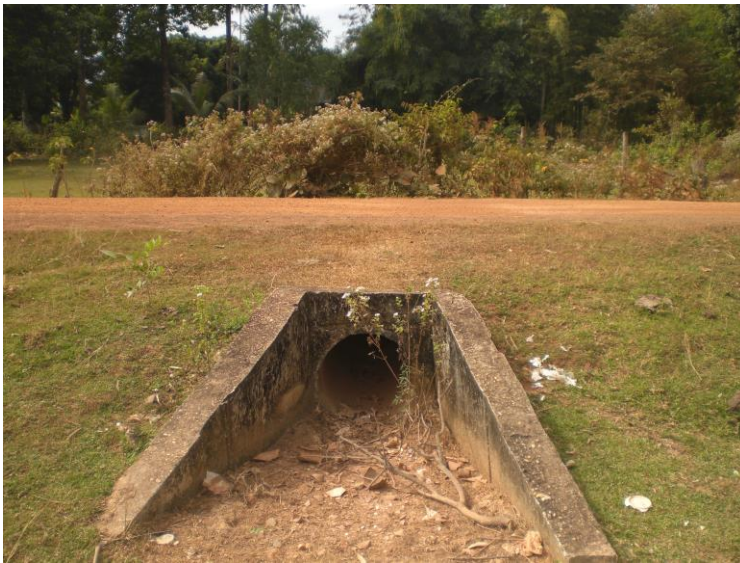
To the left is a drainage culvert crossing the same KDP road as in the previous photograph.

One can see that the road maintenance committee have spent much time removing grass and cleaning this accessible and well-designed culvert/ head wall/apron installation.

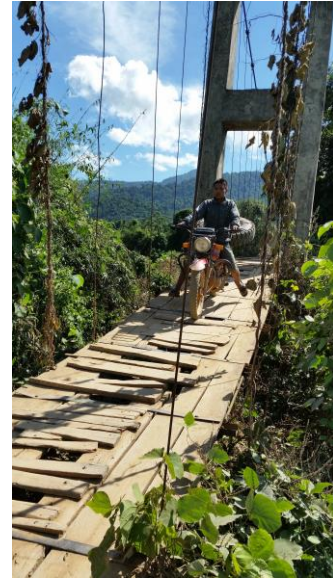
In Nongkham Village, Luang Namtha, a PRF suspension bridge has been used for a long time (built in Cycle 8, 2010) and its deck is in dire need of repair. The villagers are planning to replace the running surface of the bridge and also change parts of the cabling and fasteners that have degraded.

This rehabilitation has been estimated to cost approximately 23 Million Kip, however they have only 4,260,000 Kip in their village O&M account (collected from their village alone). The O&M Committee decided to collect money from the neighbouring villages that use the bridge from time to time, such as Ban Donyeng (5.6 Million Kip), Ban Luangphakham (4.5 Million Kip) and Chomcheng (9 Million Kip). The self-help effort will now go ahead.
